MOPAR MUSCLE CARS OF AUSTIN

January 2009

Mopar Tech

by Mark Hamilton

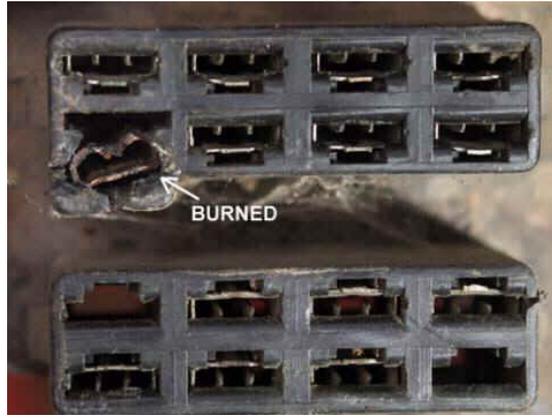
The plastic connector body surrounding the female flat blade terminal is beginning to melt away. And severe oxidation of the terminal itself is evidence that this terminal has been glowing hot. Notice that the other terminals in the connector body are still in good condition. The rusty appearance of this terminal is typical of wire terminals that have been hot while handling large amounts of current flow. (If moisture had caused the oxidation, all the terminals would have been corroded.)

After removing the connector with the red 10 gauge battery charging wire, a close inspection revealed that this side of the AMP gauge circuit was also suffering from a case of "terminal illness." (See arrow in photo at the left. This is the terminal used by the 10 gauge red wire at arrow "B," above.)

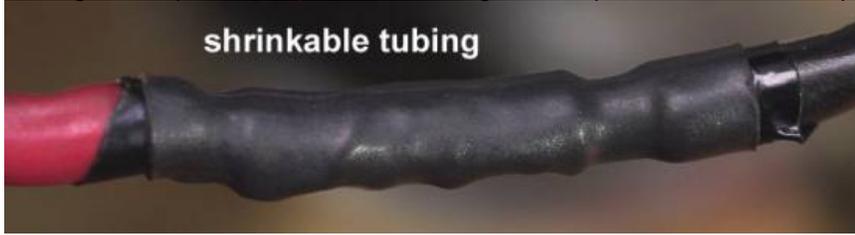
Then slide the shrinkable tubing into place, and apply heat to shrink the tubing tightly for a good seal. A disposable lighter works well when there is no breeze. A heat

gun works very well and is safer too, as it is flameless. Hair driers do not produce enough heat to activate the better shrinkable tubing. **(The splice shown in the photos above is where we have disconnected and by-passed the AMP gauge at the dash.)**

After stripping the ends of the wires, we slipped shrinkable tubing down the wire. Then we **crimped** the non-insulated butt connector onto the wires. And **then soldered** the connection.

Electrical tape may be used for the first layer of insulation, before slipping the shrinkable tubing into place. (We are using this option because it provides a little extra padding and insulation over the splice.)

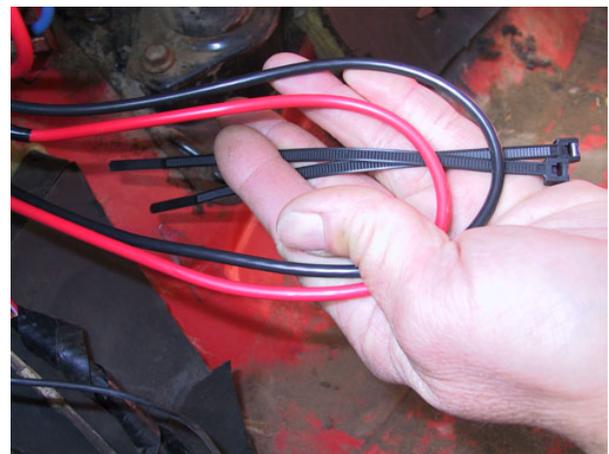
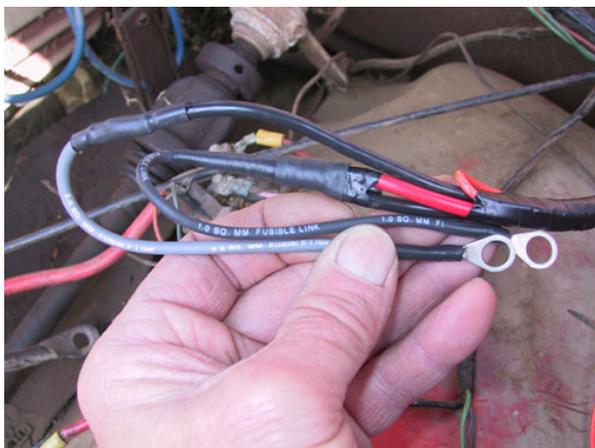
The photo at left shows the fusible Link installations, where the new wires will connect to the battery positive stud at the starter relay.

The red and black 10 gauge wires connect to a 16 gauge fusible link wire, which is actually identified as a metric size on this particular fusible

link. (1.0 sq mm is the metric equivalent of 16 **American Wire Gauge** size.) This circuit powers up the welded splice in the dash harness, which powers up all switches, fuses, and circuits at the entire dash area.

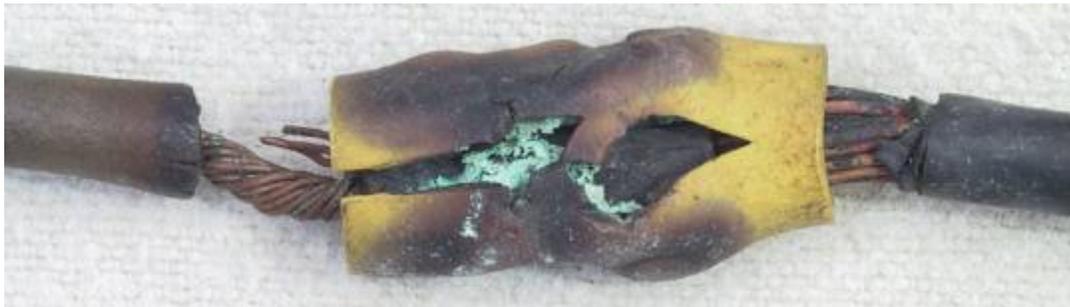
Crimp-on connectors will not be good enough! They are prone to "Thermal Run-away" problems, which is exactly what happened to the crimped on butt connector shown in the above photo.

Craftsmanship will have to be good, for the new system to be reliable. We are working with the main power delivery to the entire electrical system. Current to operate the entire system will flow from the alternator, through this circuit, every time the vehicle is driven.
