MOPAR MUSCLE CARS OF AUSTIN

January 2009

Mopar Tech

by Mark Hamilton

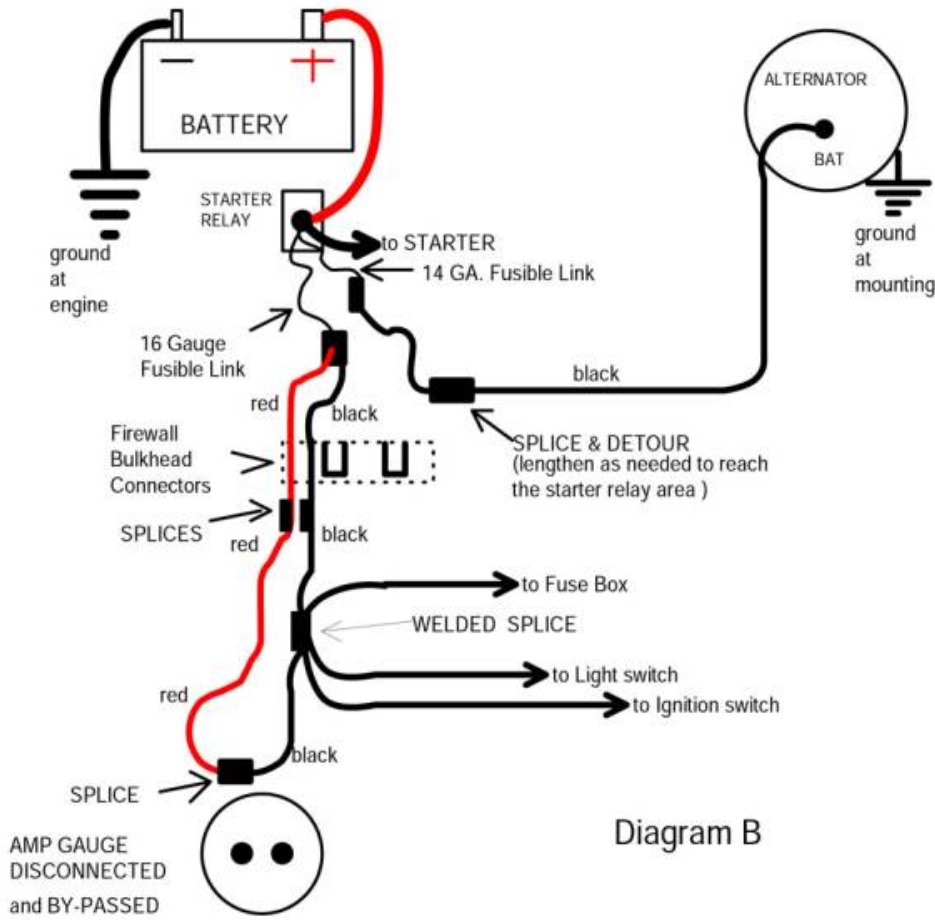
When everything is working properly, the alternator is the source of power to the entire electrical system. With this new system, we have alternator output delivered to the BATTERY POSITIVE stud at the starter relay. The stud at the starter relay now becomes the "main buss" for power distribution. Battery charging current will flow directly to the battery, via the positive battery cable. The "welded splice" in the dash wire harness still serves as a junction for power distribution—but now we are sending power to the "welded splice" through both of the existing wires that were part of the old AMP gauge system. And the AMP gauge is by-passed.

The system mostly uses existing wires that were already in the wire harness. But since we are disconnecting, bypassing, and ignoring the AMP gauge, we can rearrange the wires to form a much stronger system. The male/female terminals at the firewall connector are also by-passed, the wires now pass directly through connector body connection.

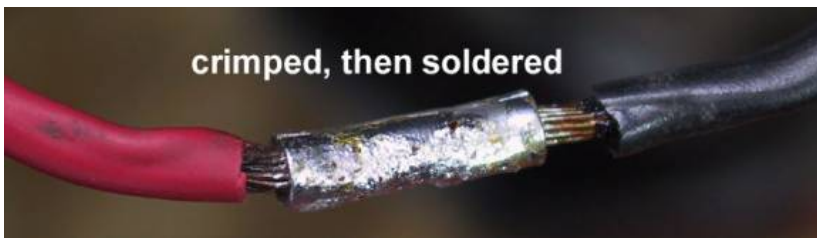
We have also used the proper Fusible Link wires for short circuit protection. A 14 gauge Fusible link is protecting the 10 black wire circuit to the alternator. And a 16 gauge Fusible link protects the power-up wires to the "welded splice," which serves as main power distribution to the dash area.

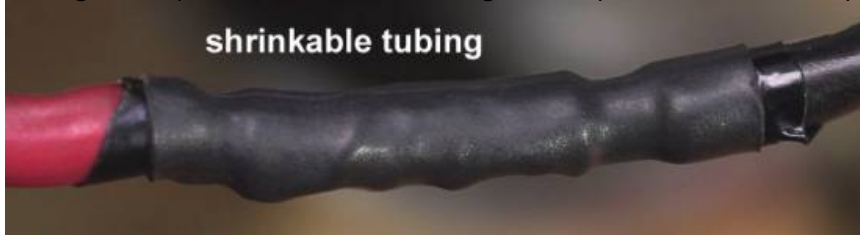
Electrical tape may be used for the first layer of insulation, before slipping the shrinkable tubing into place. (We are using this option because it provides a little extra padding and insulation over the splice.)

Then slide the shrinkable tubing into place, and apply heat to shrink the tubing tightly for a good seal. A disposable lighter works well when there is no breeze. A heat

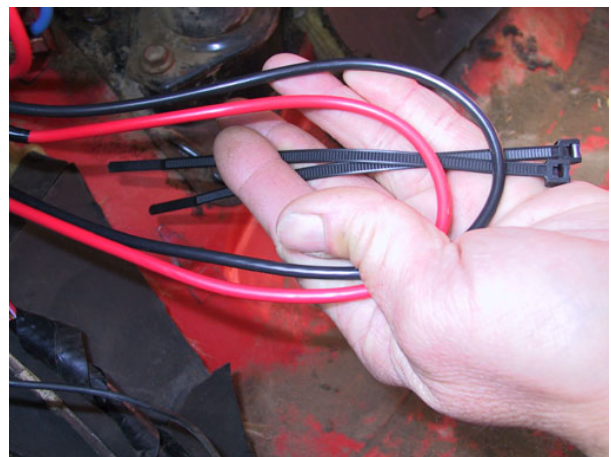
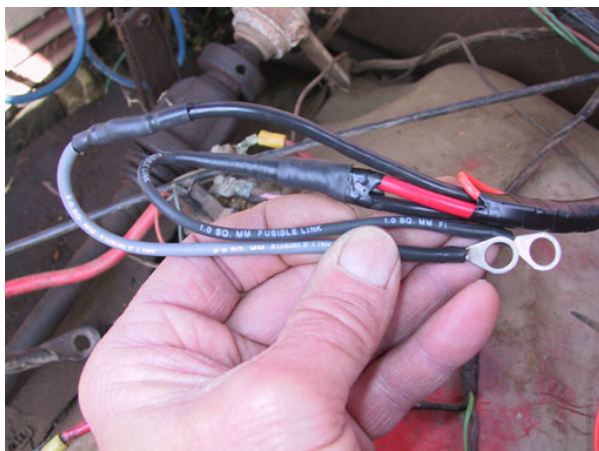
The photo at left shows the fusible Link installations, where the new wires will connect to the battery positive stud at the starter relay.

The red and black 10 gauge wires connect to a 16 gauge fusible link wire, which is actually identified as a metric size on this particular fusible

link. (1.0 sq mm is the metric equivalent of 16 **American Wire Gauge** size.) This circuit powers up the welded splice in the dash harness, which powers up all switches, fuses, and circuits at the entire dash area.

Short-circuit protection for the black 10 gauge wire to the alternator is provided by a 14 gauge fusible link (the light colored of the two, which is actually a 2.0 sq mm metric equivalent.)

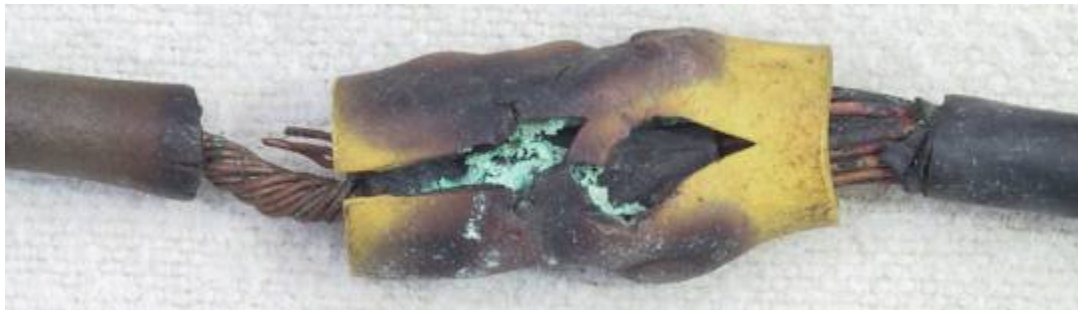
Craftsmanship will have to be good, for the new system to be reliable. We are working with the main power delivery to the entire electrical system. Current to operate the entire system will flow from the alternator, through this circuit, every time the vehicle is driven.

Crimp-on connectors will not be good enough! They are prone to "Thermal Run-away" problems, which is exactly what happened to the crimped on butt connector shown in the above photo.

M.A.D. offers very quality non-insulated terminals made of "tinned" (solder coated) copper, which are perfect for the crimp first, then solder, then insulate with shrinkable tubing connections. (As with the splice that shown in this feature.)
